CLADDING DISASTERS – SIMON PITCHERS

DATE: JUNE 2010

CLADDING NIGHTMARES

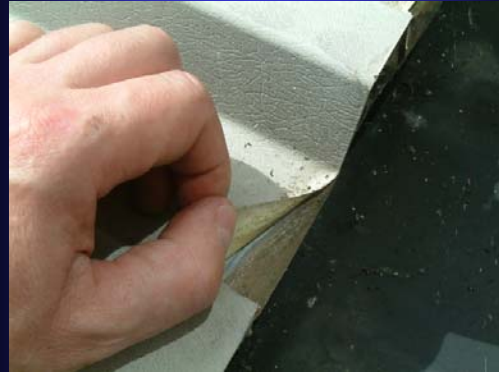
INSPECTION 2006

10 years after installation

- Specialist edge sealant system
- Example: Giromax Technologies Ltd – Seamsil (www.giromax.co.uk)
- Needs to be carefully specified and applied.
- Organic finish to modern cladding is allegedly superior to HP200
- Consider self-colour aluminium when specifying (WATCH FIXINGS)

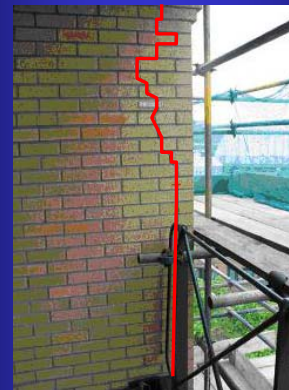
THE INITIAL PROBLEM

- Cracking at high level in a brick panel
- Concern of the unknown
- Concern of falling masonry onto footpath below

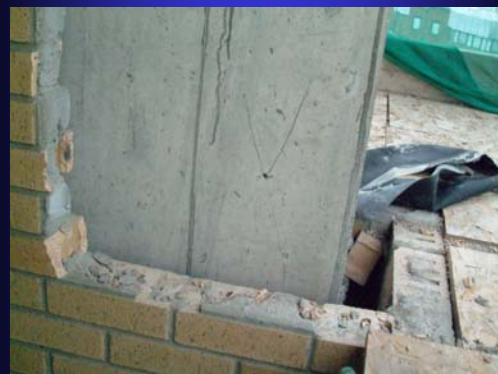
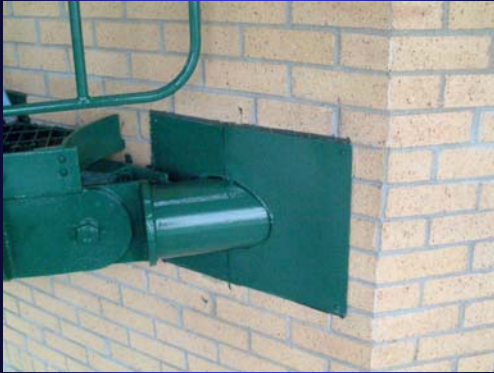
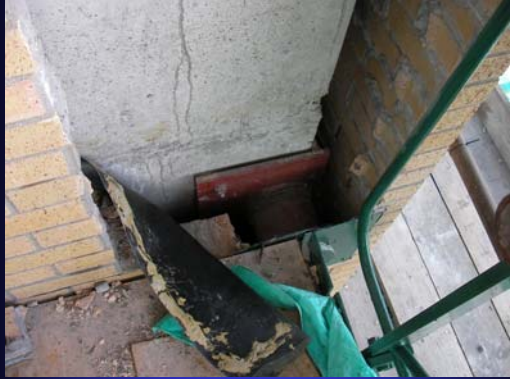
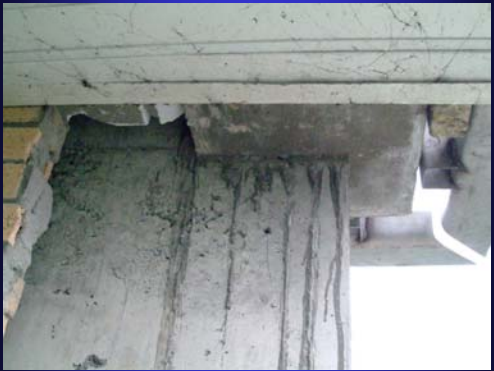
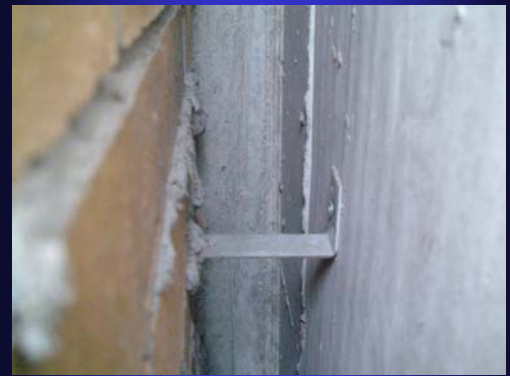
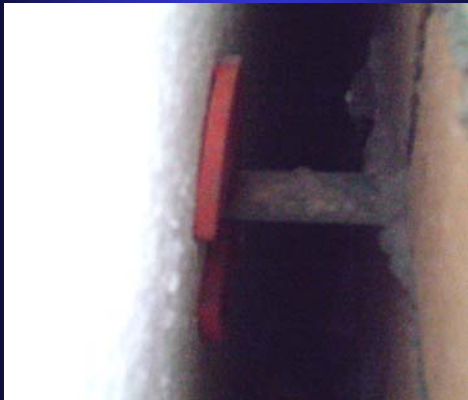
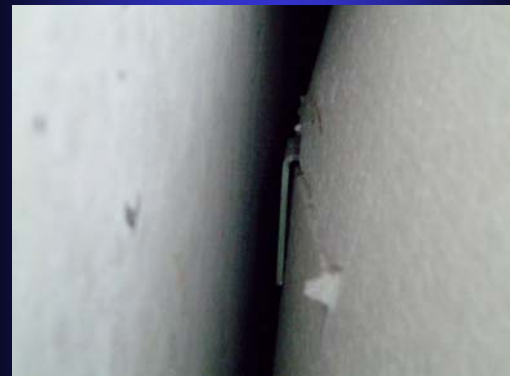
INVESTIGATION

- Scaffolding (needed for redecoration under terms of the lease)
- Opening up cracked area

- Initiating crack caused by frame restraint
- Corbel restraint suspect
- Lack of ties from brick to inner leaf and around openings
- MSA fixings suspect. Twisted? Not taking load
- Lack of ties within 375 over MSA
- Cracking from unbroken columns of bwk

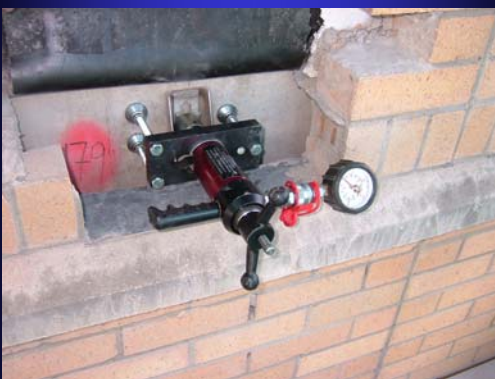
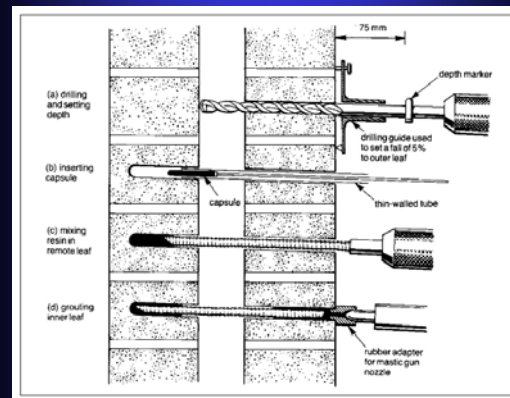
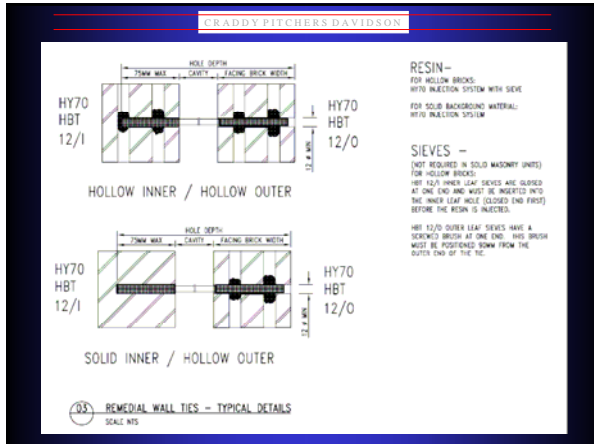
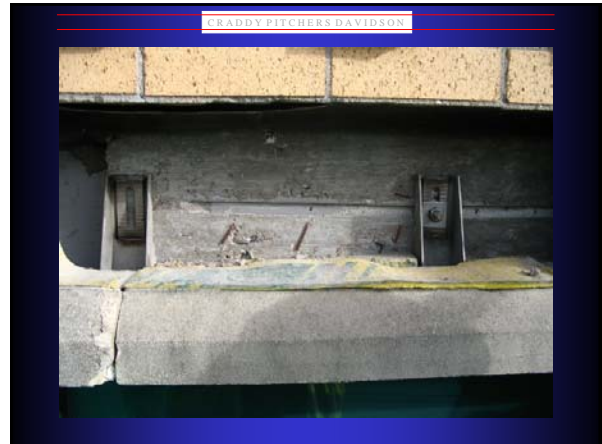
FINDINGS OF FURTHER INVESTIGATION

- Insufficient ties 375 above MSA
- Low tie density where concrete inner leaf and around openings
- Adequate tie density where block inner leaf
- No twist to MSA; sufficient brackets
- MSA fixings into RC ok; 25% shortfall in core areas
- Widespread cumulative cracking at tops and sides of masonry columns

- CRADDY PITCHERS DAVIDSON
- ## REVIEW REMEDIAL WORKS SPEC
- Retrofix ties to core areas, 375 above MSA over ribbon windows and next to openings and mvt joints
 - Cut and fill below MSA
 - Isolate cols from wall panels
 - Rebuild or tie corbels where distorted
