CLADDING DISASTERS – SIMON PITCHERS

DATE: JUNE 2010

CLADDING NIGHTMARES

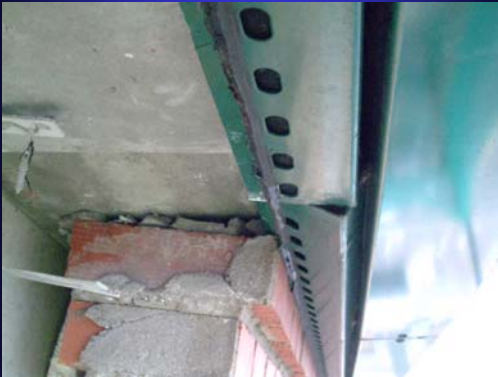
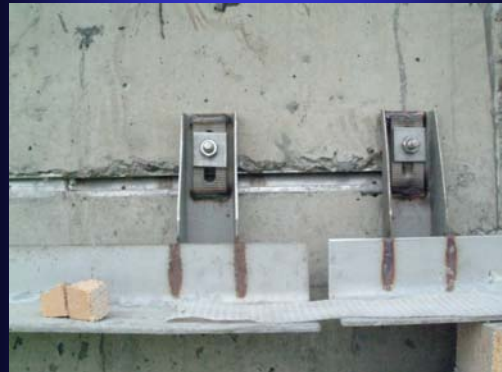
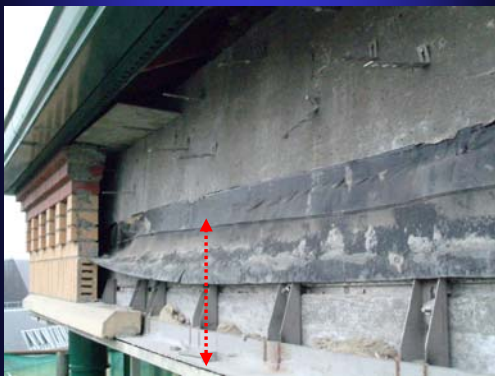
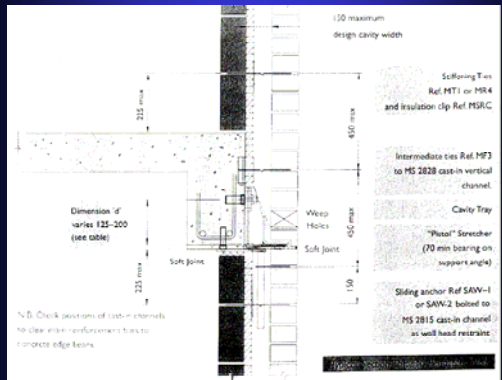
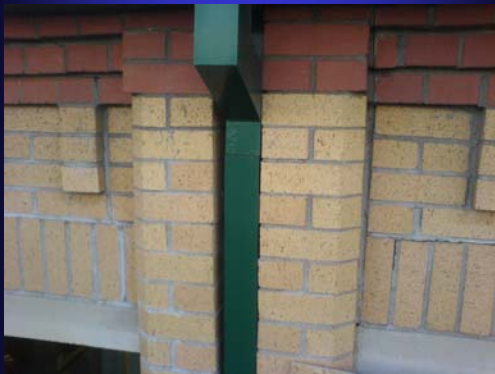
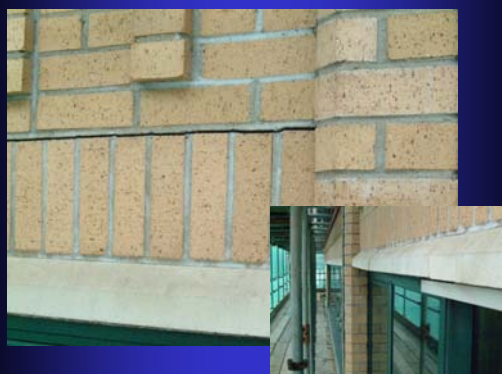
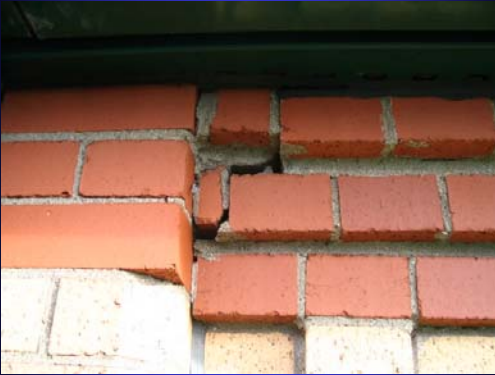
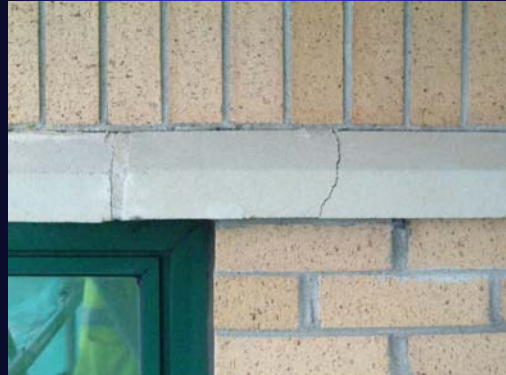
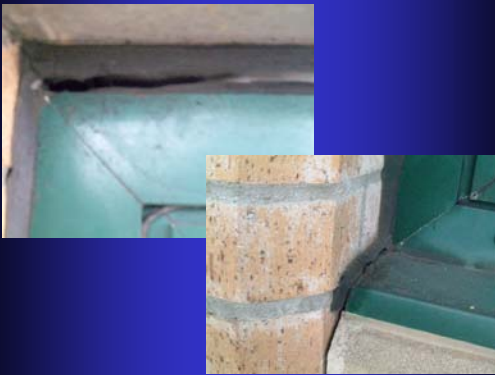
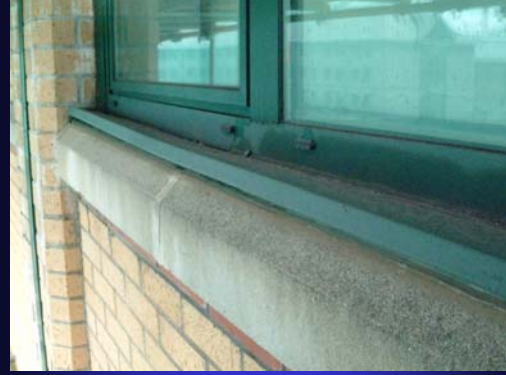
RESULTS OF INITIAL INVESTIGATION

- Initiating crack caused by frame restraint
- Corbel restraint suspect
- Lack of ties from brick to inner leaf and around openings
- MSA fixings suspect. Twisted? Not taking load
- Lack of ties within 375 over MSA
- Cracking from unbroken columns of bwk
